Engineering Geomorphological Assessment and Slope Hazard Identification of the Haast Pass Highway Corridor

State Highway Six, Haast Pass, New Zealand

Master of Science in Engineering Geology

by
Andrew Timothy Walsh
2015

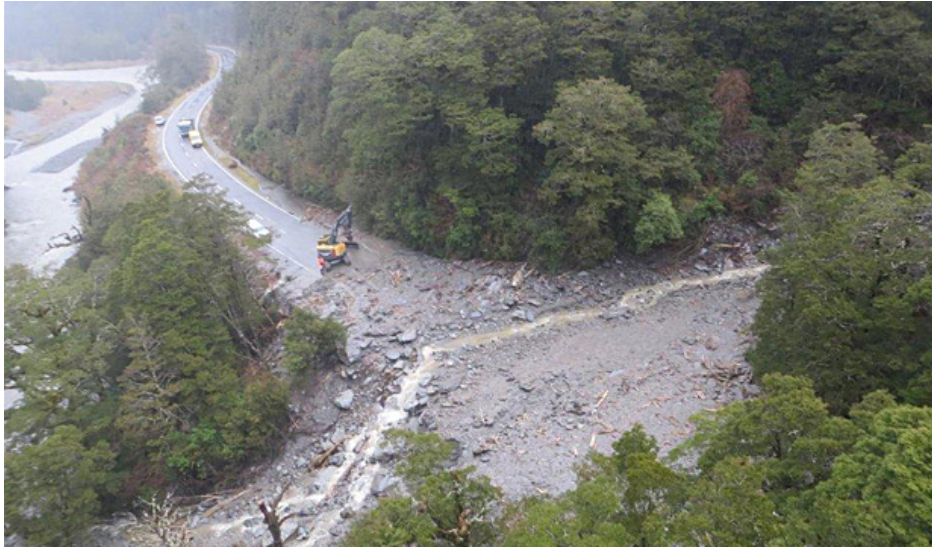
The debris flow that occurred on the 10th September 2013 at Pipson Creek provides the most recent illustration of the impact that these events can have on the highway. During a night of heavy rainfall that triggered numerous other landslides in the Haast Pass a debris flow travelled down Pipson Creek and due to the lack of capacity at the small culvert at road level crossed the highway. Analysis of the air photo of Pipson Creek shows the debris flow path beginning near an area of instability at the apex of the debris fan and travelling all the way to the highway and into the Haast River (Figure 4.2). A 30 metre section of the highway was covered beneath several metres of debris consisting of boulders, cobbles, gravel and trees. This single event was significant enough to close the highway by itself, however, the presence of several other landslides including the very large landslide at Diana Falls contributed to the road being closed for much longer.

The debris flow during the 2013 event resulted in the highway being closed as debris needed to be cleared, a section of the road was damaged and needed to be repaired and the culvert that normally carries Pipson Creek needed to be reconstructed, however, impacts of this event extend beyond disruption and damage to the highway. It was not until several days later that it became apparent that two tourists were missing and had last been seen on the Wanaka side of a landslide at Ford Creek. After several days of searching, wreckage of their campervan was found wrapped around a boulder in the Haast River. The subsequent coroners inquest determined that the tourists had most likely been swept into the Haast River by the debris flow at Pipson Creek, killing them instantly. This highlights that these events not only have the potential to cause significant disruption and damage to the highway itself, but also have the possibility to cause fatalities for the occupants of any vehicle caught in the path, be it a car, campervan or bus.

Figure 6.1: This photo shows where the Pipson Creek debris flow crossed the highway covering it in several metres of boulders, cobbles and gravel. It is at this site that two tourists were reported to have been impacted by the debris flow and washed into the Haast River. An excavator can be seen removing material to try and clear the highway (Photo Credit:NZTA).

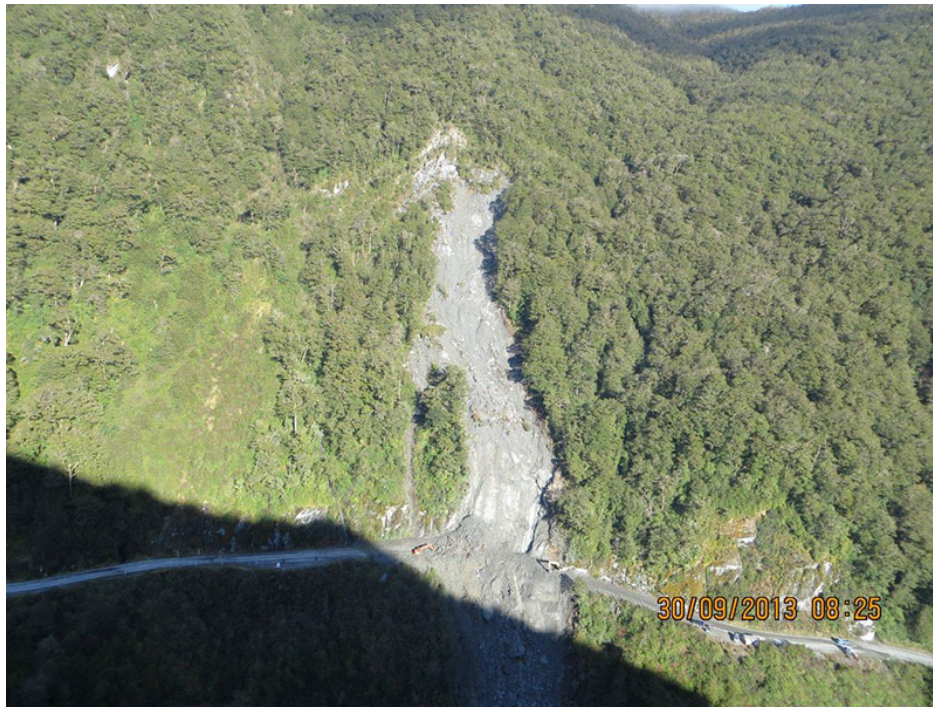
The large debris slide episode that began on the 10th September 2013 at Diana Falls provides a recent illustration of the initial and ongoing impacts that debris slides can have on the highway. An initial slide with a volume estimated at 20,000m³ occurred on the 10th September affecting a 50m section of the highway and resulting in closure for 10 days as further slides and boulders rolling down slope made clearance dangerous. Another large debris slide on the 27th September 2013 resulted in 10,000m³ of material sliding down slope from the area above the initial head scarp and again resulted in the highway's closure. In the months after the two large debris slides rainfall events continued to initiate smaller slides that resulted in further road closures and clearing works.

The debris slides resulted in severe disruption to highway operation , with the road only open intermittently during the day and closed at night from September 2013 to November 2014. Damage to the highway was extensive with a new surface having to be installed as well as a half bridge and a new culvert to carry the water running over the waterfall. The loss of material from the slope has also left the head scarp and lateral scarps unsupported presenting an ongoing debris slide hazard to the highway. To temporarily deal with this hazard and reopen the highway, rockfall fences and debris drapes have been installed to catch the larger boulders and funnel future debris slides alongside the cliff at highway level and away from the road. While this may work in the short term, the considerable maintenance cost of the fences and concerns with the potential for larger failures at the site was outlined in section 5.2 suggesting that the fences are a short term solution

Figure 6.2: Photo of the Diana Falls debris slide taken after the second large event that resulted in extension of the slide up slope on the 27th September 2013 (Photo taken 30/09). The State Highway Six can be seen running across the bottom of the image with the highway below the slide covered by debris. (Photo Credit:NZTA).

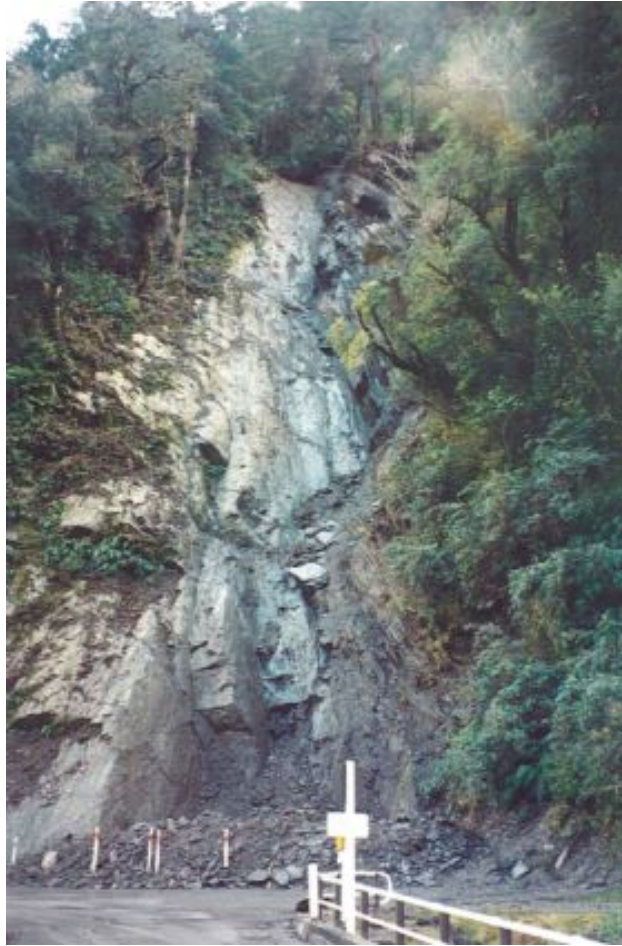
Past rockfall events in the Haast Pass have occurred as isolated rockfall events and as a component of debris sliding episodes such as the ongoing problems with individual boulders falling down from the scarp of the Diana Falls landslide. The example provided here is from a well documented rockfall hazard site at the northern approach to the Gates of Haast bridge that was the subject of an engineering report by Paterson (1994). On the 29th September 1994 a rockfall originating from a gully on the northern side of the Gates of Haast bridge resulted in rock debris inundating the highway. The rock debris consisted of boulders between 0.5 and 1 metre in diameter as well as a finer component of cobble sized particles. The investigation noted that the gully that the rockfall was sourced from extended 100 metres above the highway and consisted of boulders between 2 and 4 metres in diameter. The report also noted that the young age of vegetation at the head of the gully suggested that the site had probably been the site of previous rockfall events. The impact of the rockfall on the highway was relatively minor with no damage to the bridge and only superficial damage to the highway as it was unsealed at the time. Luckily no road users were impacted by falling rocks as an impact would probably result in serious injury or death by the impact itself or by being forced off the highway and down the steep bank into the river. The site presented an ongoing hazard as large boulders remained at the head of the gully that could potentially fall onto the highway. The solution reached at this site was to construct a gabion bund at the base of the gully in the approximate location of the debris in Figure 6.3.

Figure 6.3: Photo showing the rock fall gully on the north side of the Gates of Haast bridge. Schist boulders originate from the top of the gully and the unstable right side of the gully. Recent rockfall material can be seen at the base of the gully and consists of boulders between 0.5 and 1 metre across with a finer fraction consisting of cobbles and gravel. The debris has been left in place as a temporary bund to trap subsequent rock fall events (Photo Credit:Engineering Report (Paterson 1994))

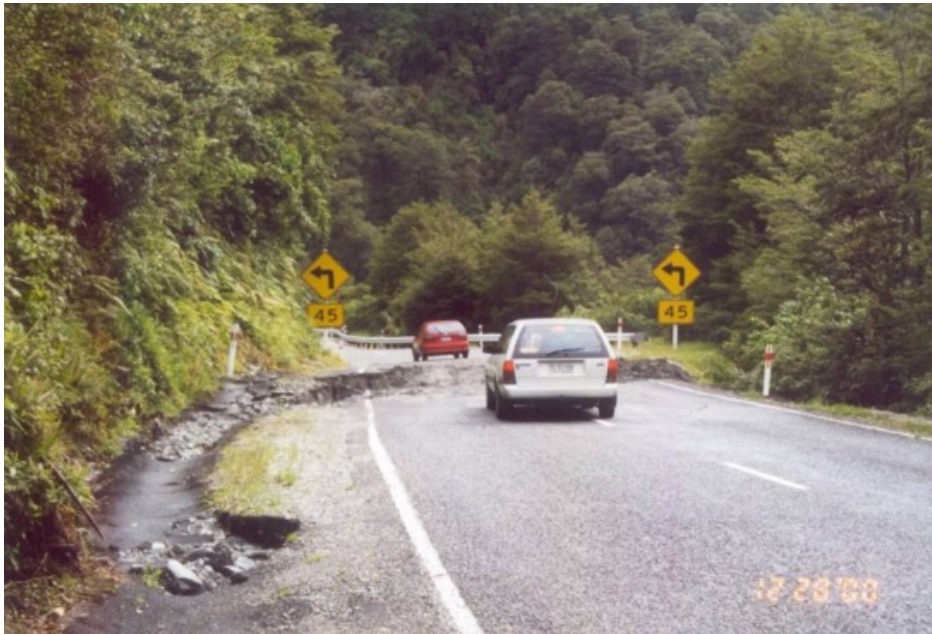
Damage to the highway consisted of a number of holes that had opened in the road surface that were allowing water into the slope and damage at both ends of the slope where half metre scarps had broken the road surface (Figure 6.4). The highway suffered some disruption, but as Figure 6.4 shows vehicles were still able to travel across the affected section. Remediation work consisted of infilling the collapsed section of the road with 500mm of engineered fill and then resealing of the highway. A month after the resealing had taken place there was evidence of continued creep of the debris slide as cracks began to appear in the new seal and water was entering through new swallow holes on the up slope side allowing water to travel beneath the highway.

Slumping of the highway has been an ongoing problem at the site with the seal having to be repaired periodically as movement continues and as such is monitored closely (E. Stevens, personal communication, April 21, 2014). The debris slides appears to have been mobilised by heavy rainfall combined with erosion of the toe of the slope by the Haast River 100 metres below the road at the site of the photo in Figure 6.4. Highway collapse will continue to be a problem at this site and at many other sites as heavy rainfall and undercutting of slopes in the northern zone continues to drive debris sliding.

Figure 6.4: Photo of the highway at The Hinge showing the effects of a partial collapse of the highway. A 120 metre section of the highway dropped 650mm and the effect of this drop-out can be seen in the image. The photographer is standing on the dropped section of highway with a scarp visible just in front of the white car and the sinkhole on the left side of the highway in the bottom right corner (Photo Credit:Engineering Report (Opus 2001))

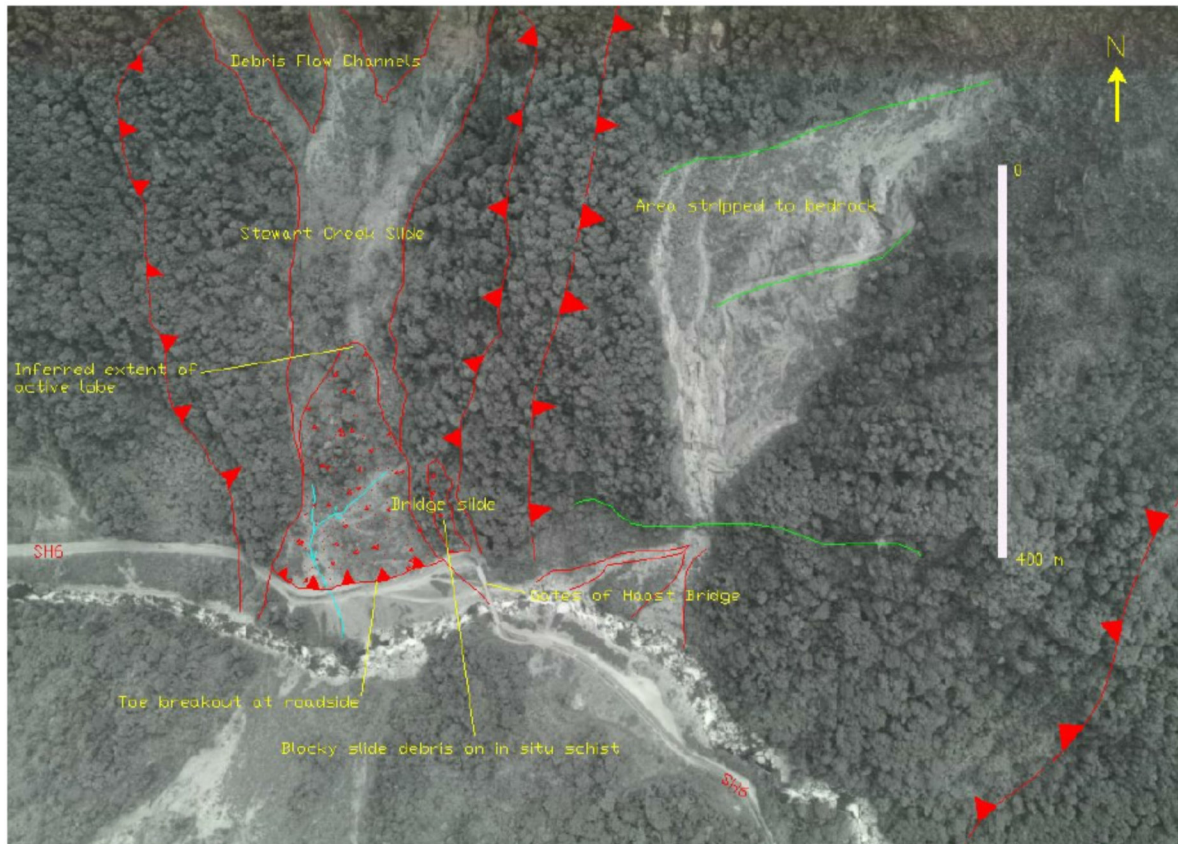
Figure 2: Annotated aerial photograph taken in 1992 showing the active debris flow/slide channels and the active nature of the slope processes (Opus 2001).
